**Análisis de las propiedades constructivas vulnerables comparativas al reglamento
de edificaciones peruano para viviendas en las Vegas, provincia de Picota, región**

San Martín - 2022

Tesis

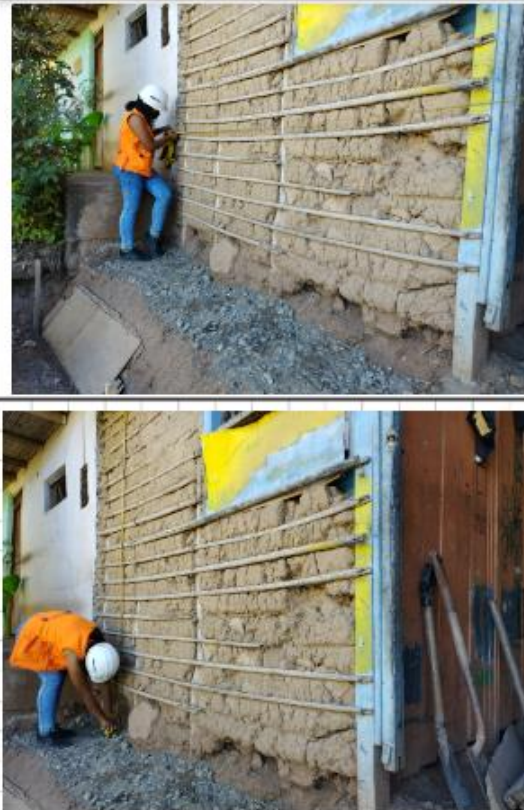
Figura 17

Vivienda 02 – Nivel 01

Exterior Falling Hazards: Unbraced Chimneys Heavy Cladding or Heavy Veneer
 Parapets Appendages
 Other: Coberturas en mal estado

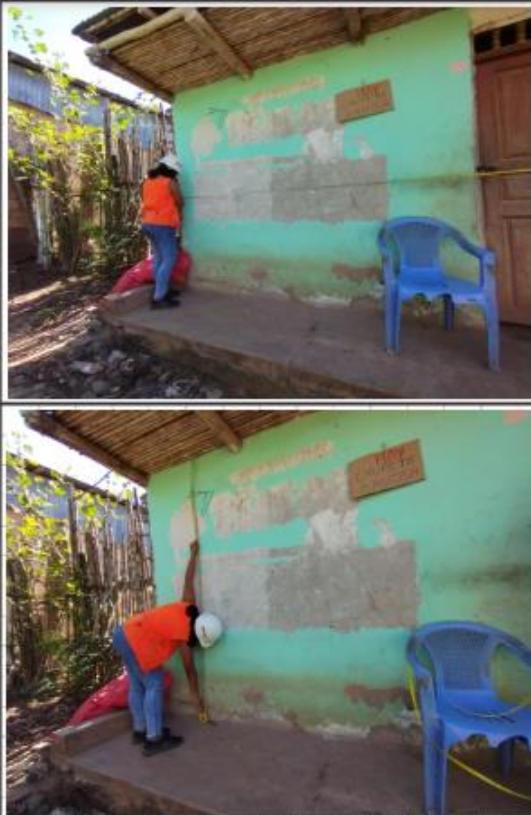
Figura 19

Vivienda 03 – Nivel 01

Exterior Falling Hazards: Unbraced Chimneys Heavy Cladding or Heavy Veneer
 Parapets Appendages
 Other: Coberturas en mal estado

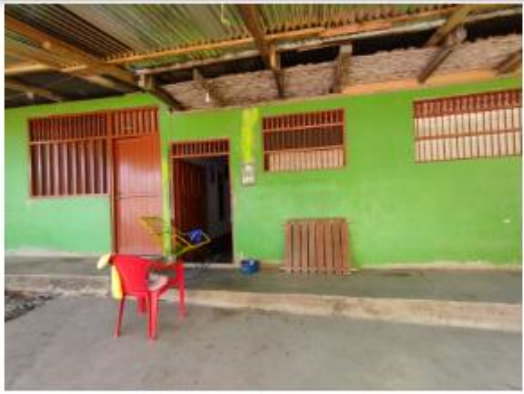
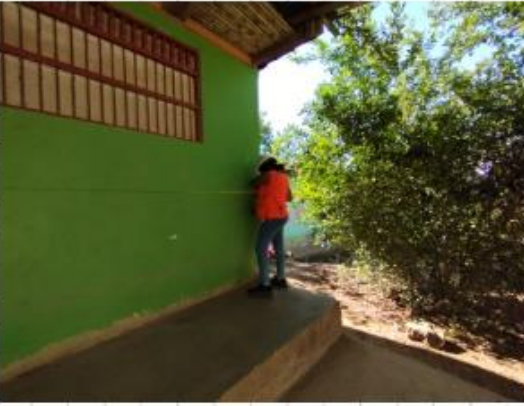
Figura 21

Vivienda 04 – Nivel 01

Exterior Falling Hazards: Unbraced Chimneys Heavy Cladding or Heavy Veneer
 Parapets Appendages
 Other: Coberturas en mal estado

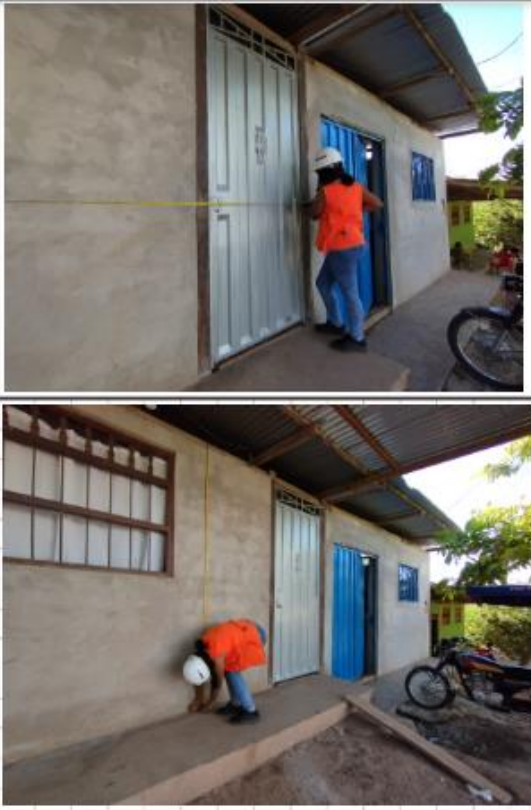
Figura 23

Vivienda 05 – Nivel 01

Exterior Falling Hazards: Unbraced Chimneys Heavy Cladding or Heavy Veneer
 Parapets Appendages
 Other: Coberturas en mal estado

OBSERVABLE NONSTRUCTURAL HAZARDS					
Location	Statement (Check "Yes" or "No")	Yes	No	Comment	
Exterior	There is an unbraced unreinforced masonry parapet or unbraced unreinforced masonry chimney.		x		
	There is heavy cladding or heavy veneer.		x		
	There is a heavy canopy over exit doors or pedestrian walkways that appears inadequately supported.		x		
	There is an unreinforced masonry appendage over exit doors or pedestrian walkways.		x		
	There is a sign posted on the building that indicates hazardous materials are present.		x		
	There is a taller adjacent building with an unanchored URM wall or unbraced URM parapet or chimney.		x		
	Other observed exterior nonstructural falling hazard:		x	Cobertura inestable	
Interior	There are hollow clay tile or brick partitions at any stair or exit corridor.		x	Falta de confinamiento	
	Other observed interior nonstructural falling hazard:		x	Cobertura inestable

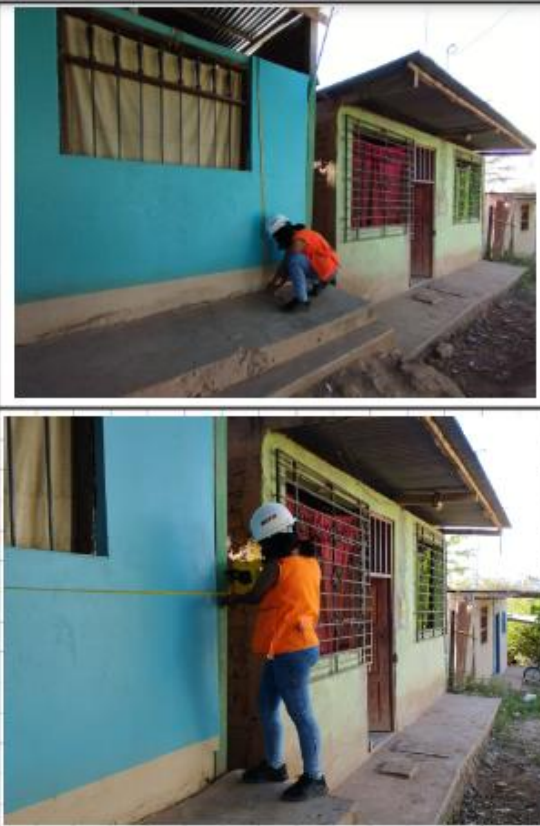
Figura 27

Vivienda 07 – Nivel 01

Exterior Falling Hazards: Unbraced Chimneys Heavy Cladding or Heavy Veneer
 Parapets Appendages
 Other: Coberturas en mal estado

OBSERVABLE NONSTRUCTURAL HAZARDS					
Location	Statement (Check "Yes" or "No")	Yes	No	Comment	
Exterior	There is an unbraced unreinforced masonry parapet or unbraced unreinforced masonry chimney.		x		
	There is heavy cladding or heavy veneer.		x		
	There is a heavy canopy over exit doors or pedestrian walkways that appears inadequately supported.		x		
	There is an unreinforced masonry appendage over exit doors or pedestrian walkways.		x		
	There is a sign posted on the building that indicates hazardous materials are present.		x		
	There is a taller adjacent building with an unanchored URM wall or unbraced URM parapet or chimney.		x		
Interior	Other observed exterior nonstructural falling hazard:	x		Cobertura inestable	
	There are hollow clay tile or brick partitions at any stair or exit corridor.	x		Falta de confinamiento	
	Other observed interior nonstructural falling hazard:	x		Cobertura inestable

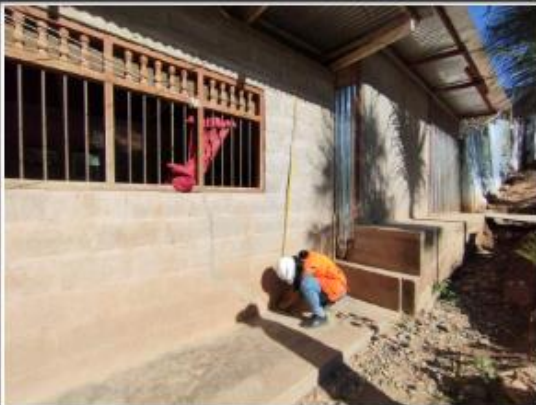
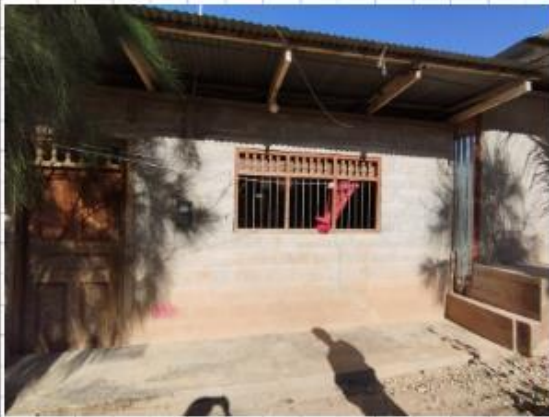
Figura 29

Vivienda 08 – Nivel 01

Exterior Falling Hazards: Unbraced Chimneys Heavy Cladding or Heavy Veneer
 Parapets Appendages
 Other: Coberturas en mal estado

Interior	Other observed exterior nonstructural falling hazard:	x		Cobertura inestable
	There are hollow clay tile or brick partitions at any stair or exit corridor.	x		Falta de confinamiento
	Other observed interior nonstructural falling hazard:	x		Cobertura inestable
Estimated Nonstructural Seismic Performance (Check appropriate box and transfer to Level 1 form conclusions)				
<input type="checkbox"/> Potential nonstructural hazards with significant threat to occupant life safety → Detailed Nonstructural Evaluation recommended				
<input checked="" type="checkbox"/> Nonstructural hazards identified with significant threat to occupant life safety → But no Detailed Nonstructural Evaluation required				
<input type="checkbox"/> Low or no nonstructural hazard threat to occupant life safety → No Detailed Nonstructural Evaluation required				
Comments:
